Emulsified oil in the radiator? Here is the likely culprit

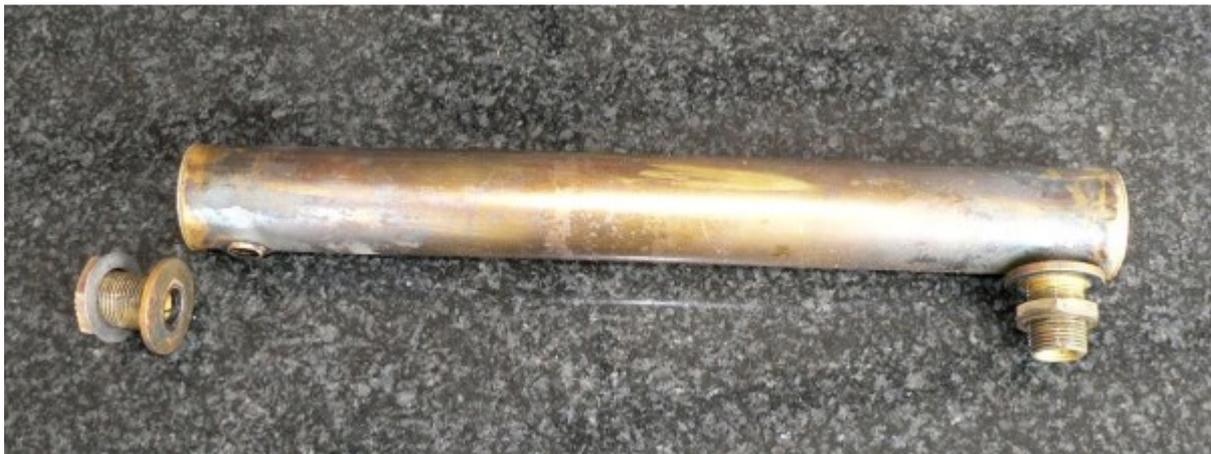
Graeme Cooper Automotive (as usual) know more about this than you are likely to find on an Internet search. The latter will have advice that typically blames a failed head gasket and if you are foolish enough to take that on trust and give the work to just any old mechanic, it is quite likely that a few thousands of dollars later, you have paid for work that was unnecessary. Fortunately, I asked the Cooper experts first and was told the most likely cause is a damaged oil cooler inside the radiator housing. (See picture).

The shaking and thumping of the radiator over the years can and probably will break one or more of the joints, even if they were properly done in the first place, using brass components. If these radiator components are tig-welded aluminium, the rate of failure is likely to be much higher again, because although it is not common knowledge, welding actually reduces the strength of the material by up to 50% and that is one reason why so many aluminium radiators fail very soon after installation – especially if the vehicle is routinely driven over rough roads and bush tracks.

Most reputable radiator specialists will not repair an aluminium radiator due to the high failure rate, so the only solutions are a new “original” unit or a copper and brass unit rescued from a wreck and re-cored. Unfortunately, both are expensive options and either may be hard to find. In the case of this author, Coopers again came to the rescue with a copper/brass unit suitable for complete restoration.
