## The Perils of Metal (and plastic) fatigue

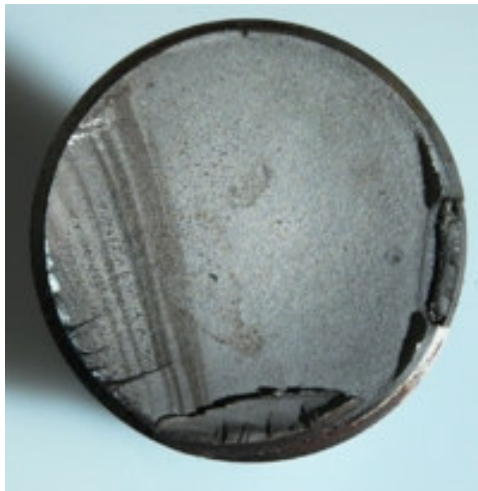
The left picture clearly shows failure through metal fatigue, caused by the bolt being stressed under load. The right hand picture is an example of a porous casting, the voids being caused by bad manufacturing.

Actually, there are two main culprits, namely *fatigue* when a component fails over time, due to stresses imposed by heat, movement or both and *porous casting* and similar poor manufacturing techniques. These illustrations show the difference:
