The Perils of Metal (and plastic) fatigue

The general public and even many motor mechanics simply fail to appreciate the severe danger that can arise from the deterioration of components over time. This article attempts to provide a simple explanation of the causes, what to look for and what precautions to take to radically enhance your safety.

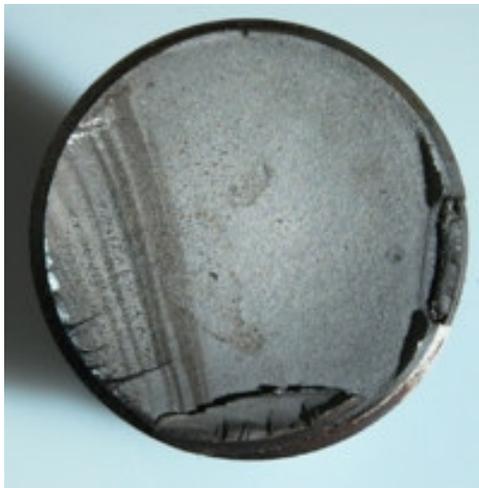
The left picture clearly shows failure through metal fatigue, caused by the bolt being stressed under load. The right hand picture is an example of a porous casting, the voids being caused by bad manufacturing. It is noteworthy that not only metals can be affected by fatigue, with plastic and rubber components being high on the "suspect" list.

Actually, there are two main culprits, namely *fatigue* when a component fails over time, due to stresses imposed by heat, movement or both and *porous casting* and similar poor manufacturing techniques. These illustrations show the difference:
